Delays And Increased Cost Result From The Zilwaukee, Michigan, Bridge Project Mishap

In August 1982 the Zilwaukee Bridge under construction on Interstate 75 near Saginaw, Michigan, experienced a near collapse caused by the failure of an expansion joint to withstand the loading stresses imposed by construction activities just prior to the mishap

GAO/RCED-84-144
JUNE 27, 1984

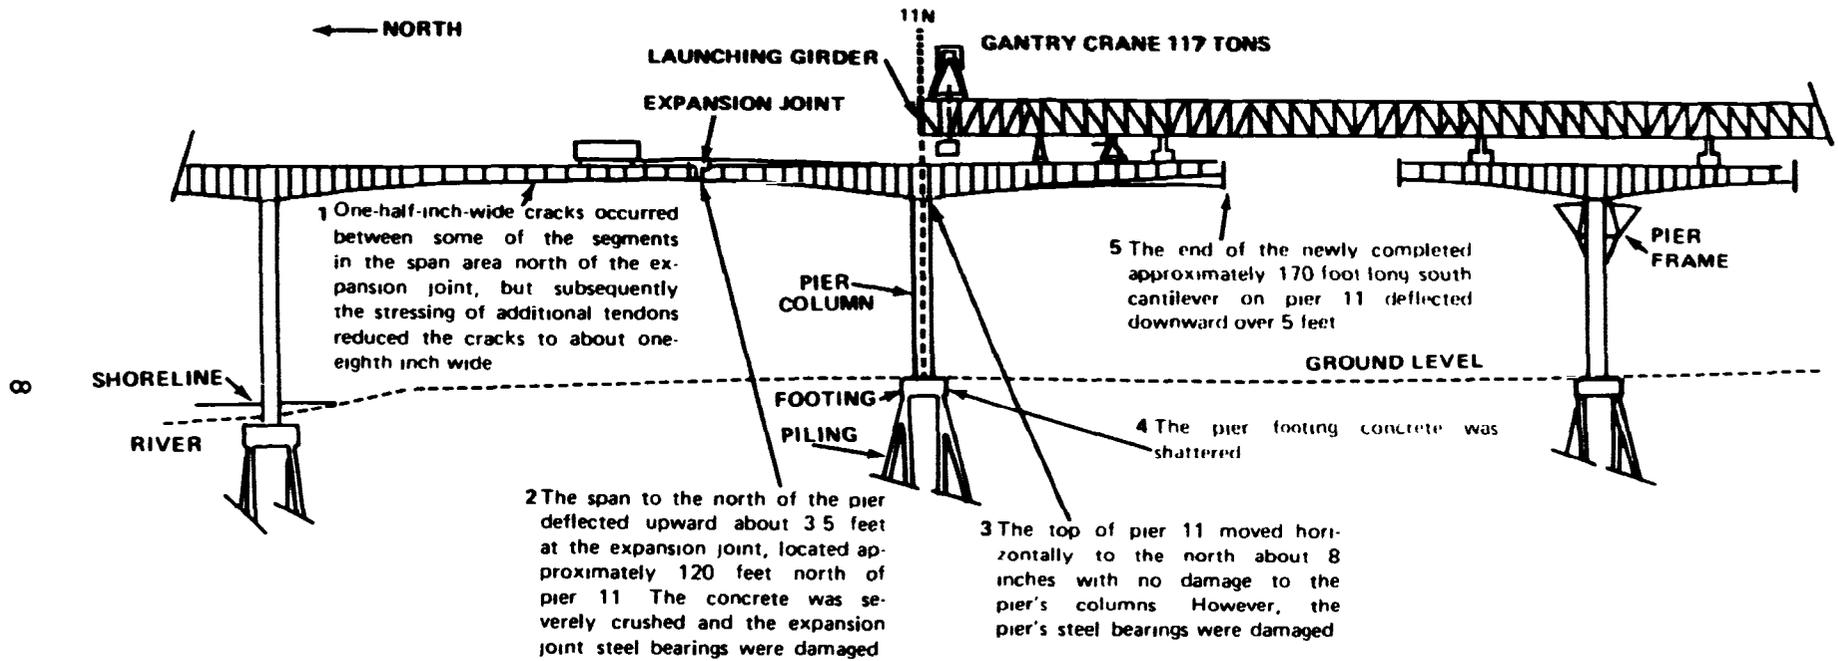
Shortly after midnight on August 28, 1982, the near collapse of a section of the northbound bridge produced or resulted in considerable physical damage to the structure. One end of an approximately 300-foot-long section of the bridge deck situated atop pier column 11 sagged over 5 feet while the opposite end rose about 3.5 feet. No personal injuries resulted. The mishap occurred moments after a large crane lifted a 157-ton concrete bridge segment from a transport truck located on the bridge. The pier columns are numbered consecutively south to north; pier 11, where the mishap occurred, is next to the river's south shore. Figure 3 on page 8 illustrates the movements and damage.

DAMAGE TO THE ZILWAUKEE BRIDGE

Investigations by three design engineering firms with segmental bridge experience all concluded that the mishap occurred when an expansion joint, which permits temperature-related expansions and contractions, failed to withstand the loading stresses imposed by construction activities just prior to the mishap. The firms, however, differed in assessing the cause of the joint failure. The construction contractor's consultant (TYLI) stated that a deficient expansion joint design by MDOT's design/construction engineer (ZCE) caused the failure. MDOT's consultant (HNTB) concluded that the failure was caused by construction loads and conditions exceeding the expansion joint's capacity. ZCE attributed the failure to contractor actions which resulted in an excessive load on the expansion joint.
